**Buffer Zone Contamination Report**

**Additional Assessment**  
(Submitted April, 2003)

**Rock Flats Environmental Technology Site**  
**Response to Concerns**  
**April 8, 2004**

**Colorado Department of Public Health and Environment  
Buffer Zone Contamination Report  
Additional Assessment (Submitted April, 2003)**

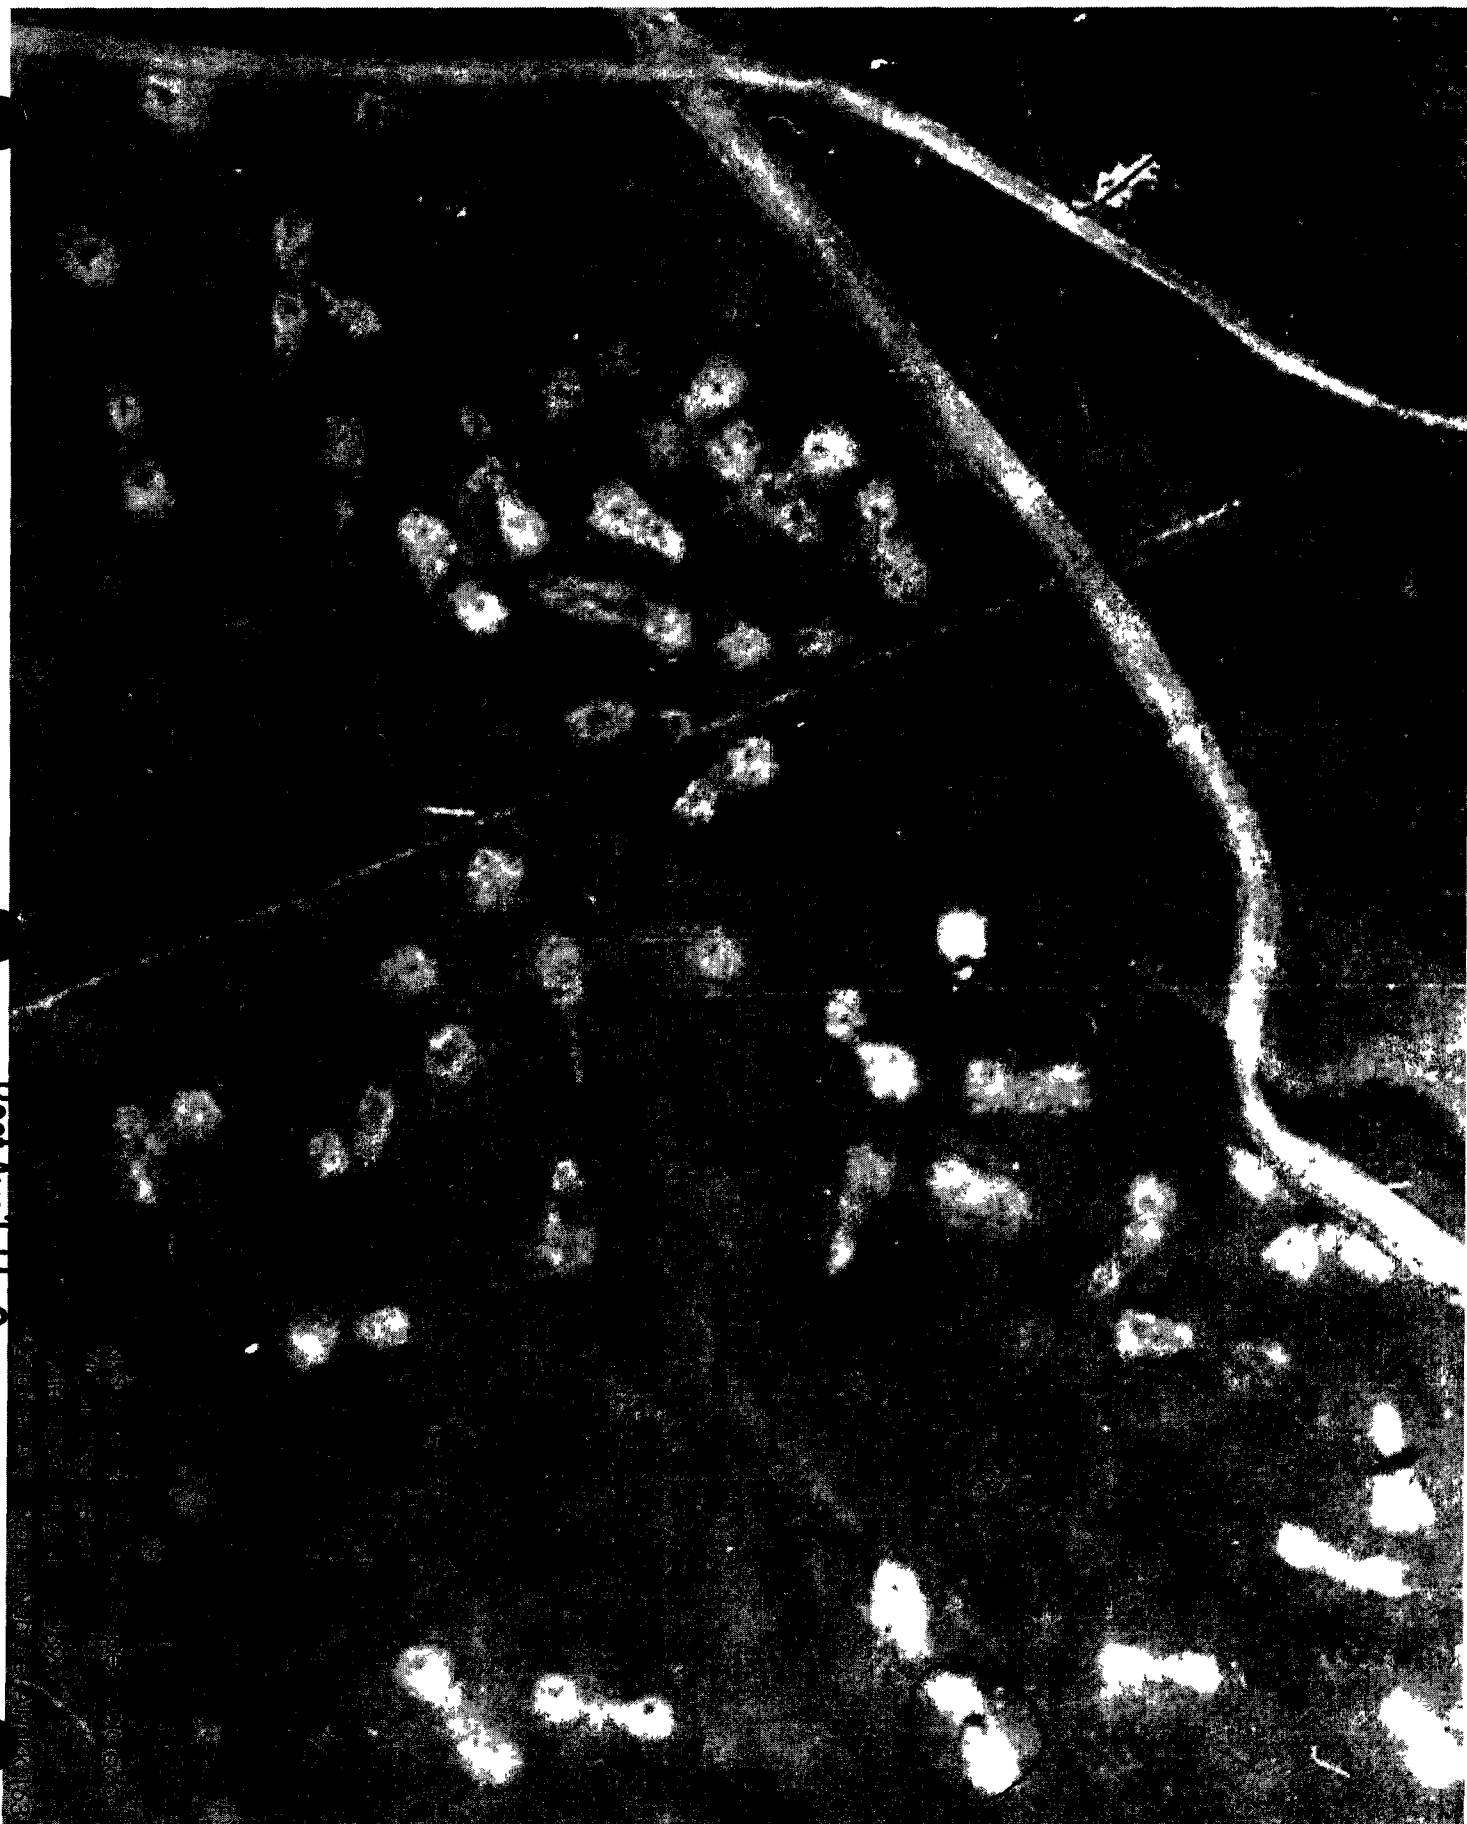
- 1) Three locations from the northern most area of features would be sampled. The areas were selected primarily based on the visible depressions within two of the areas and a concentration of features within another. Coordinates are as follows:  
X 2080782, Y 752600,  
X 2080063, Y 752599,  
X 2079676, Y 752304

- 2) Boreholes were placed within each location on February 3, 2004, and three sampling intervals were collected from 0-0.5 feet, 0.5 to 2.5 feet, and 2.5 to 4.5 feet. Samples were analyzed for radionuclides (using both alpha and gamma spectroscopy), total metals, and VOCs. If contamination was identified, further sampling would be discussed.
- 3) All sampling was conducted in accordance with the approved Buffer Zone Contamination Report SAP. Results were expedited, validated and reported to the Regulatory Agencies on February 19, 2004.

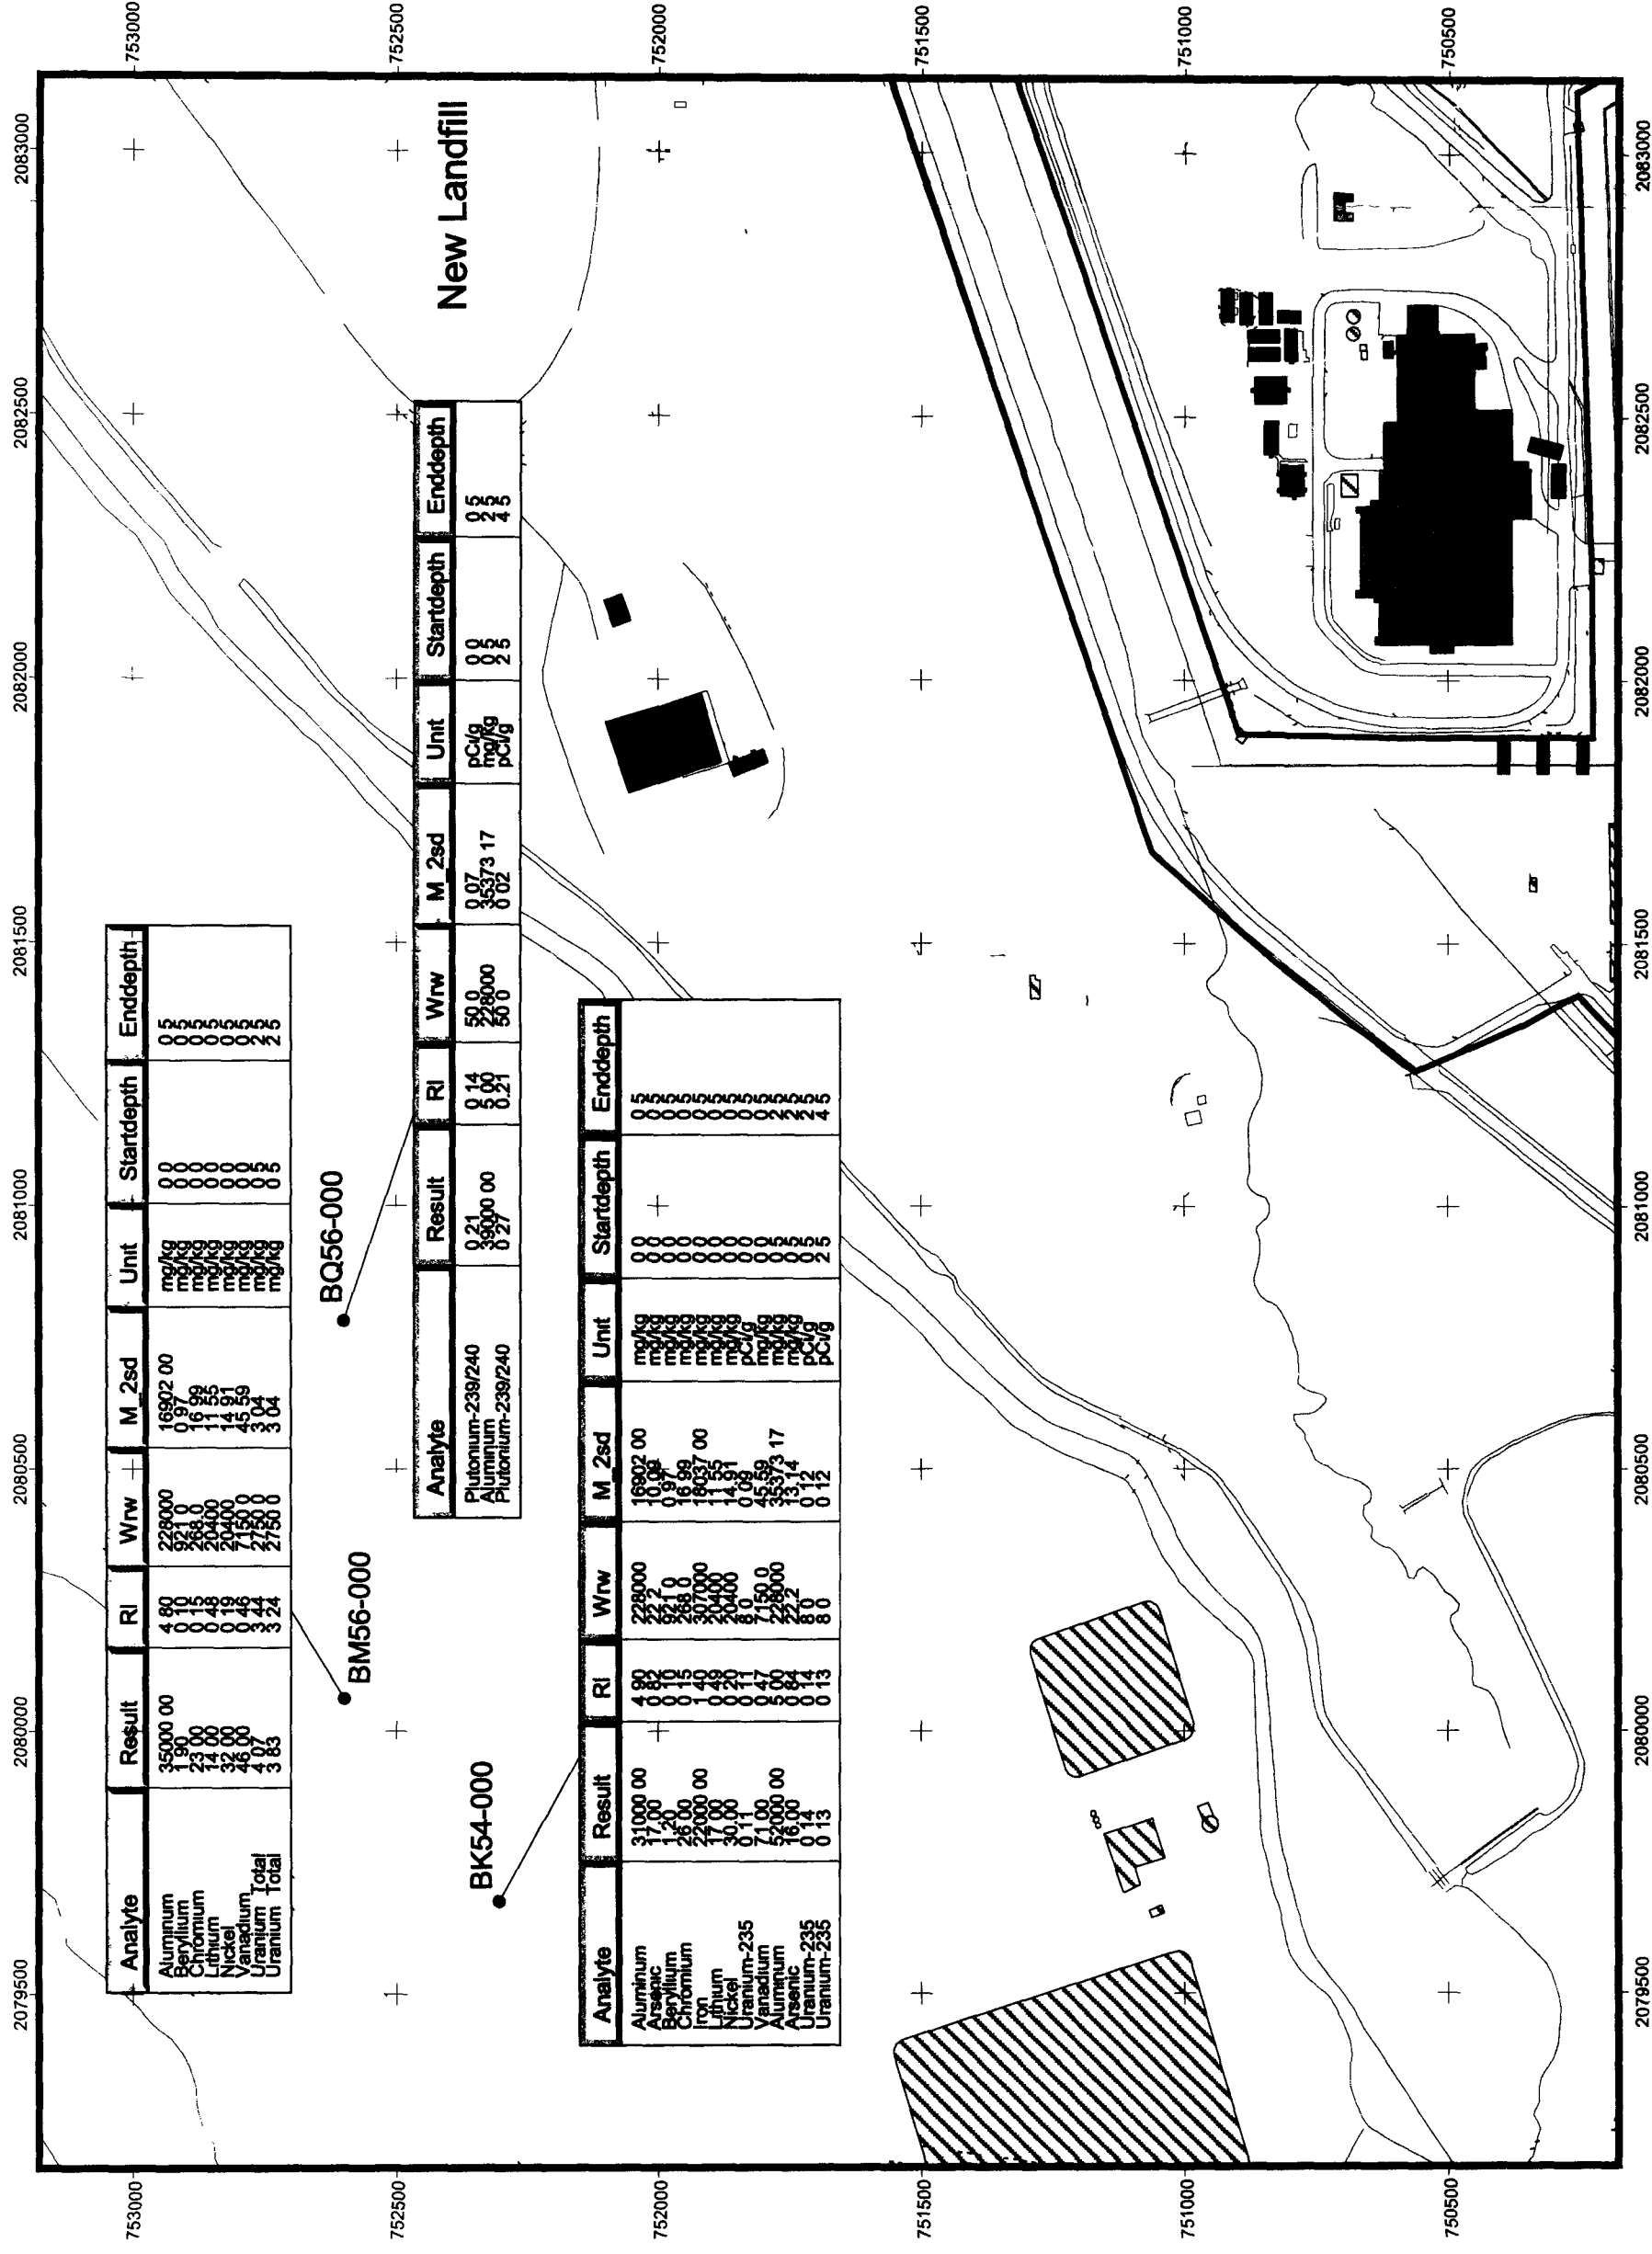
**Figure 2  
Buffer Zone  
Contamination Report  
(Site 20a)  
Borehole Results**

**Results above background mean plus 2 standard deviations and below WRW and Eco action levels**

**Explanation:** The photographs were reviewed and many individuals have been interviewed regarding the features. Several opinions were formed regarding the features in these photographs but none could be confirmed. Therefore, three locations were selected for drilling from the northernmost area of the features (shown in the 1962 and 1969 photographs) to confirm that there is no contamination present (Figure 1). Figure 2 shows the analytical data that exceeded background concentrations for the three borehole sites. Because there were no WRW or Ecological Receptor exceedances, no follow-up actions are planned for this area.
